## Project Case Study

**Plant Sump Pit Lining**  
1900 Davis Drive  
Dinuba, CA 93618

**System**  
Envirolite® 290 Organic Acid  
Lining

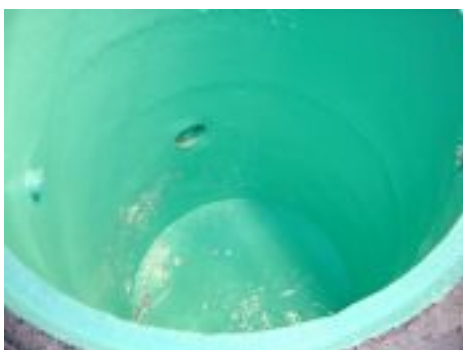
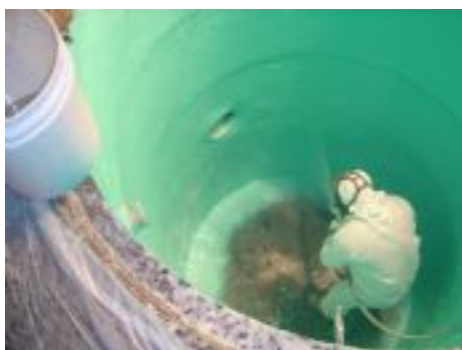
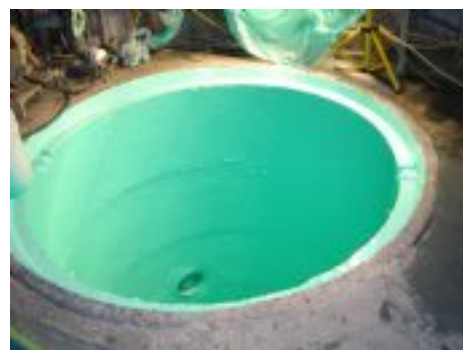
All of the drains and water at this natural juice manufacturing plant flow to one pit. Obviously after years of installing standard epoxies and coal tar epoxies, Odwalla engineers had enough of the constant corrosion and maintenance.

Polytech abrasive blasted the pit to remove all existing coatings and create a deep profile for the 40.0 mil thick Envirolite® Organic Acid Lining that would be applied. The lining was applied and the pit returned to service.

**Surface Preparation**  
SSPC-SP 13
